**ALL V12 ENGINED VEHICLES****ITEM: 29****12 REVISED GASKET AND FIXING BOLT (FASTENER) PACKAGE**

## XJ-S & S.III V12

ITEM: 30

### 12 OIL PUMPS

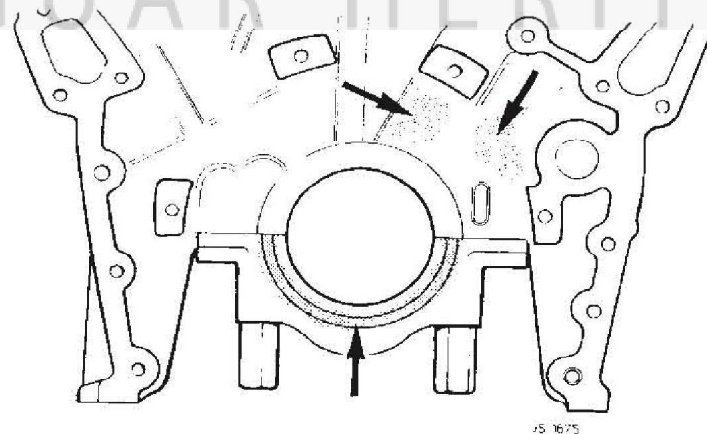
FIG 1

In most cases, the new pump can be used as a direct replacement with no modification to the block; however, in some cases, a foul condition may exist between the pump and certain areas of the old sand-cast block. To check for any foul condition, the pump should be offered in the correct position to the mounting bosses. If it lies flat against the bosses, the condition is correct. If the pump lies proud of the bosses, material should be removed from the foul area of the block (refer to shaded areas in Fig. 1 for possible foul areas) by careful use of a rotary file or similar implement.

Care should be taken when removing material to ensure that swarf produced by the operation is completely cleared from the area and that no other part of the engine, i.e. crank, main bearing, is damaged during the operation.
