Service Bulletin

REF: JD 27/94

ALL JAGUAR AND DAIMLER MODELS WITH V12 ENGINES

12 SEALING OF BOLT THREADS - OIL SUMP SANDWICH PLATE

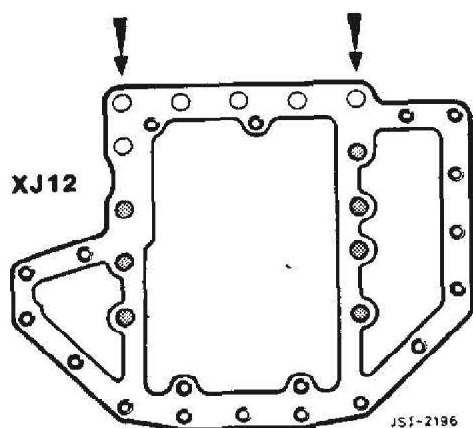
Fig. 1. XJ12 MODELS

In addition to the possibility of oil leakage at either of the above gaskets, oil may also spread upwards along the threads of certain bolts which retain the sandwich plate and baffle tray. The heads of the bolts are in contact with oil, while the tops of the threads in the crankcase are exposed externally. In the event of the oil sump being removed to allow replacement of either gasket, the threads of the bolts concerned should be sealed by the application of 'Loctite 542' sealer.

The bolts concerned are identified by shading in Fig. 1 below and in Fig. 2 opposite.

Note: (9 bolts on XJS V12 engines; 7 bolts on XJ12 engines).

Remove the bolts identified by shading; thoroughly clean and degrease them, using a suitable solvent; wipe or blow them dry.

Using a suitable solvent and a 'bottle'-type brush, thoroughly clean out any residual engine oil from the threads in the crankcase; blow out the threads using an airline.

IMPORTANT: BOTH THE THREADS OF THE BOLTS AND THE THREADS INTO WHICH THE BOLTS ARE FITTED MUST BE THOROUGHLY DEGREASED, OTHERWISE THE 'LOCTITE' 542 WILL NOT CURE TO CREATE AN EFFECTIVE SEAL.

Using a clean cloth and/or a 'bottle'-type brush, apply 'Loctite Primer' to the threads in the crankcase. Allow to dry.

When refitting the sandwich plate retaining bolts concerned, apply 'Loctite 542' to the bolt threads.

Torque setting: 21-27 Nm.
